J79-15/-17 TURBOJET ENGINE ACCIDENT INVESTIGATION PROCEDURES

F-4 SYSTEM PROGRAM OFFICE

AUGUST 1975

TECHNICAL REPORT ASD-TR-75-19

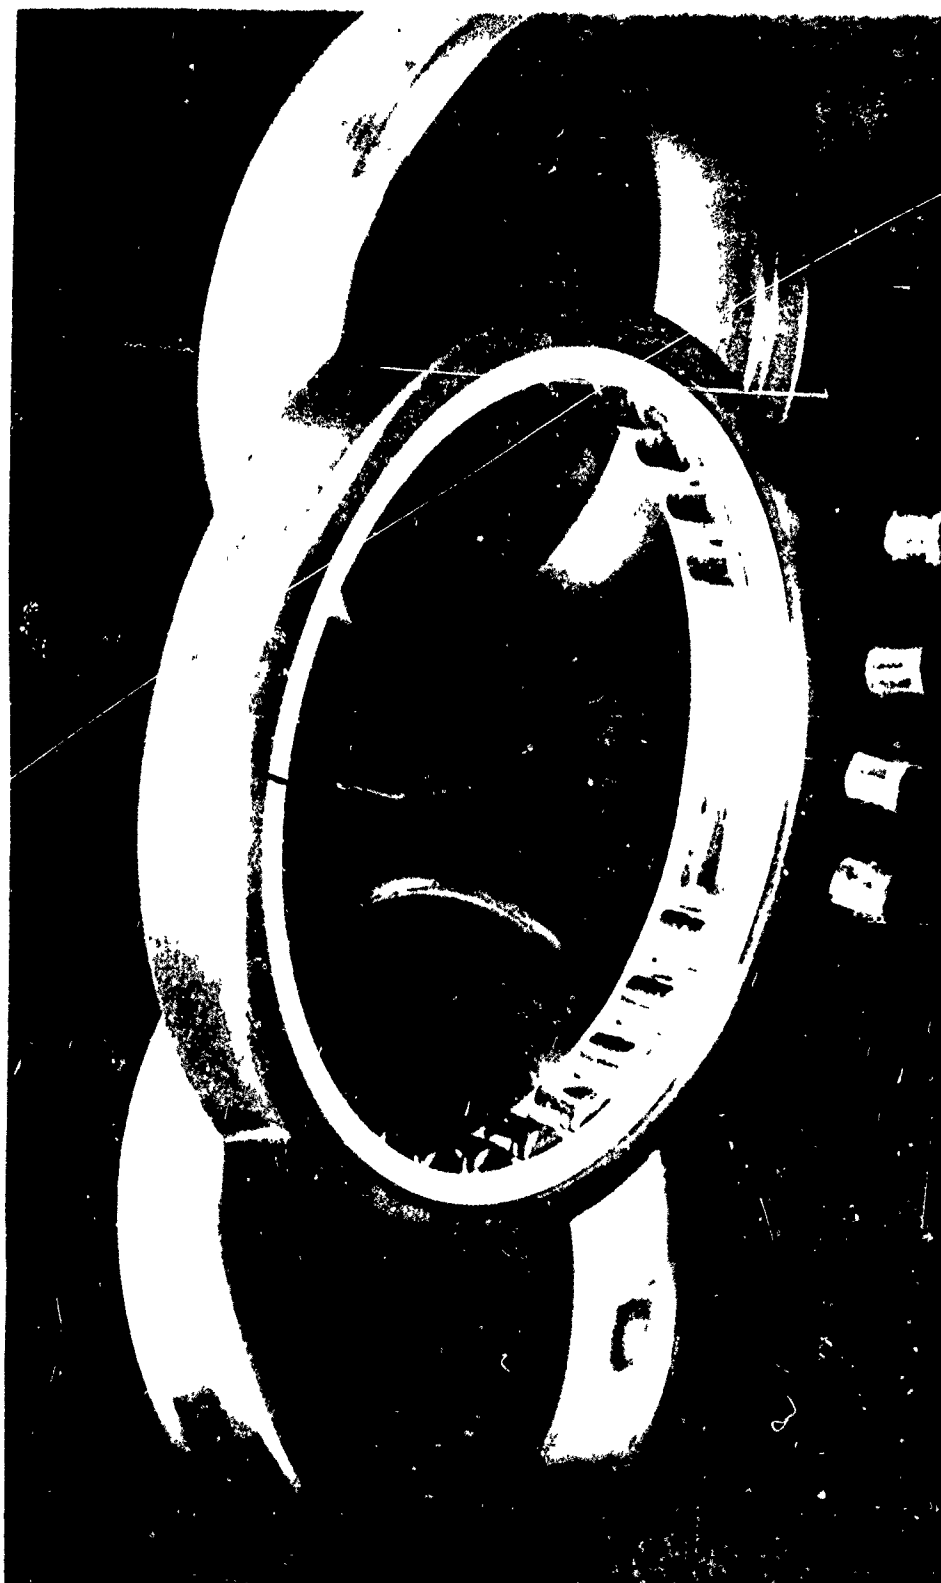
Figure 5 - Number Three Bearing Failure Type of Failure Associated with Misalignment

Remember to find out why misalignment occurred because we cannot prevent future failures unless we know the cause of misalignment.

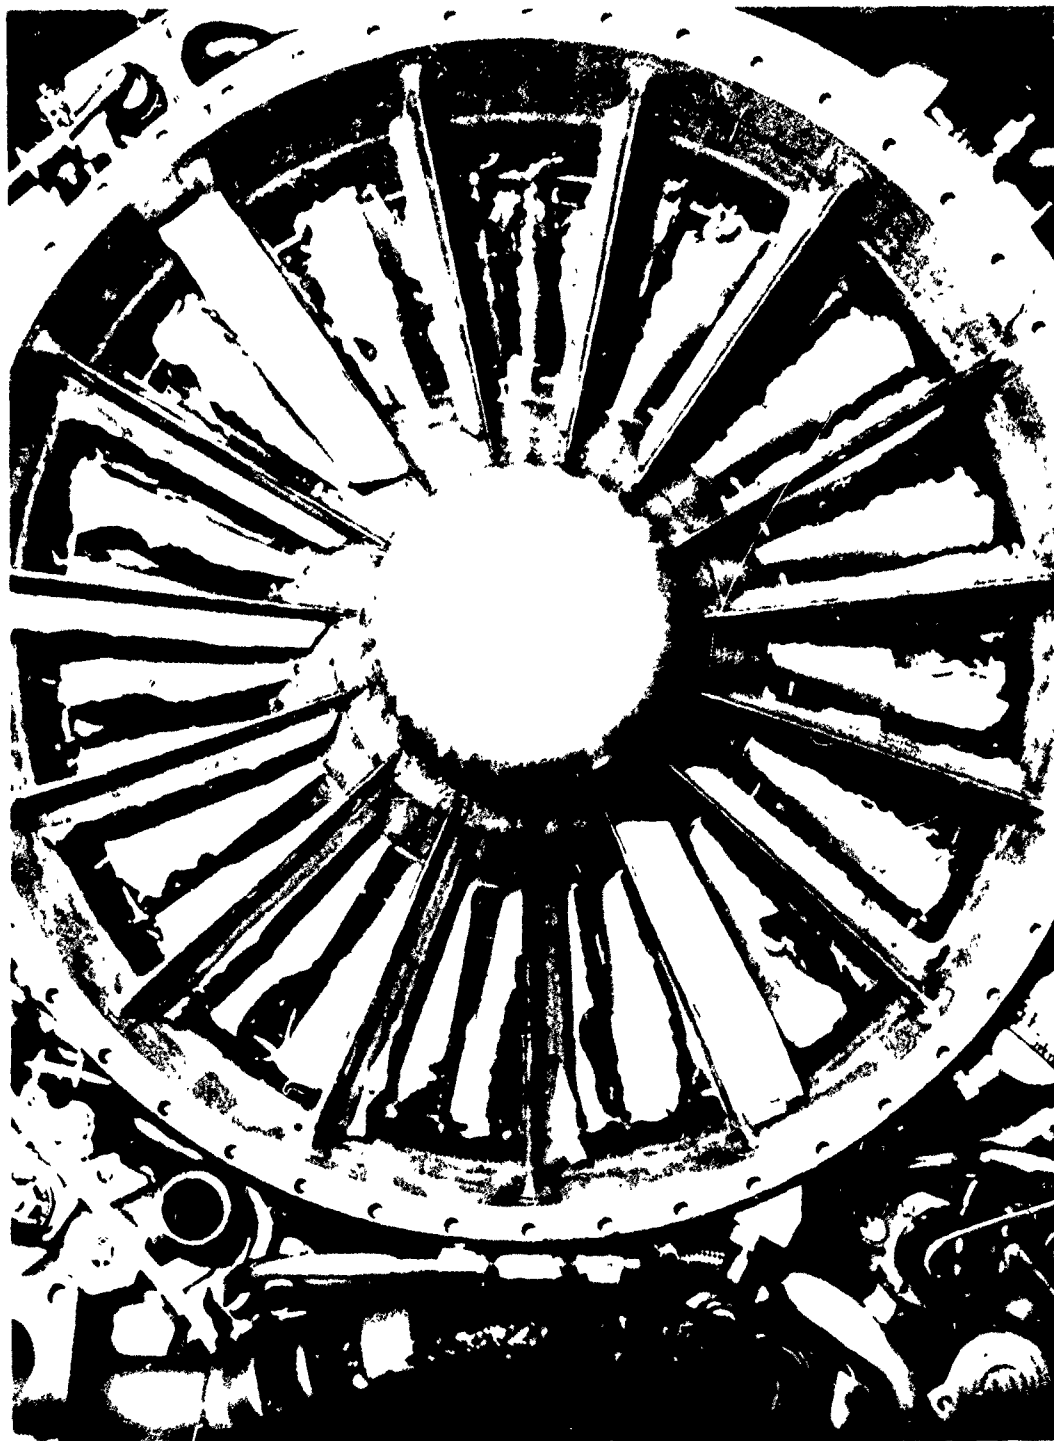
Figure 45 View of Front of Compressor After Ingesting A Foreign Object at 100% RPM Which Resulted from First Stage Blade Failure (J85 Engine)

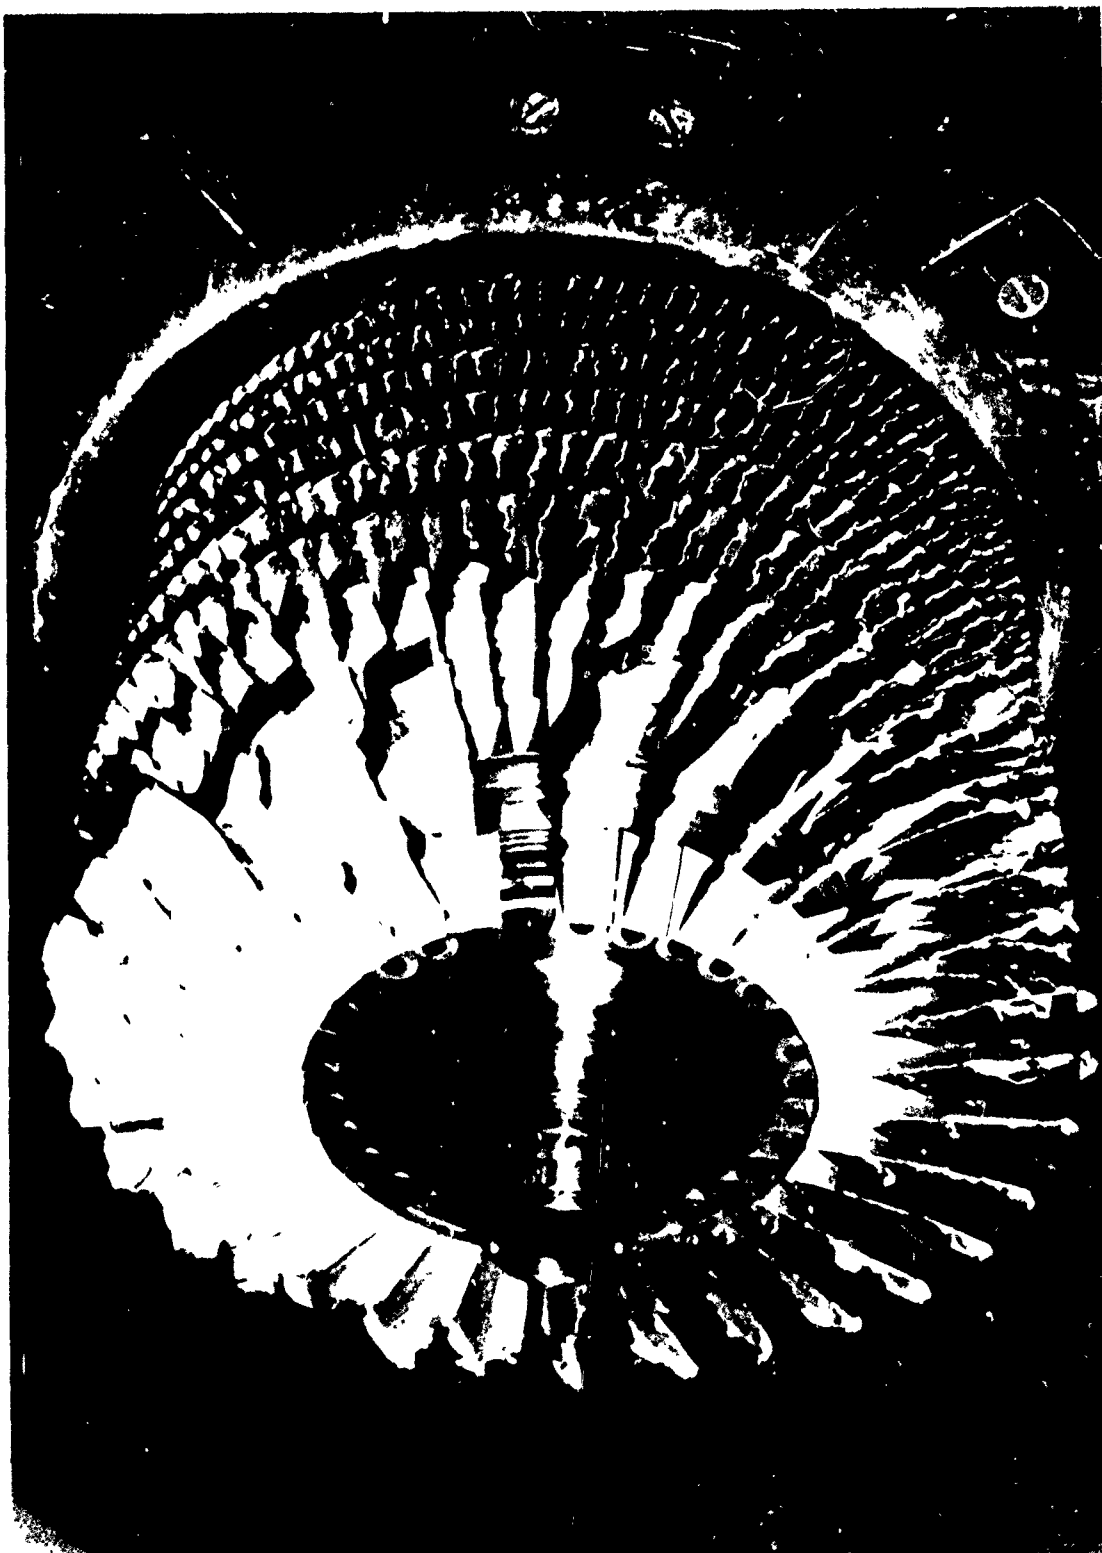
Figure 46 - View of Compressor Rotor After Ingesting a Foreign Object at 100% RPM Which Resulted from First Stage Blade Failure (I85 Engine)

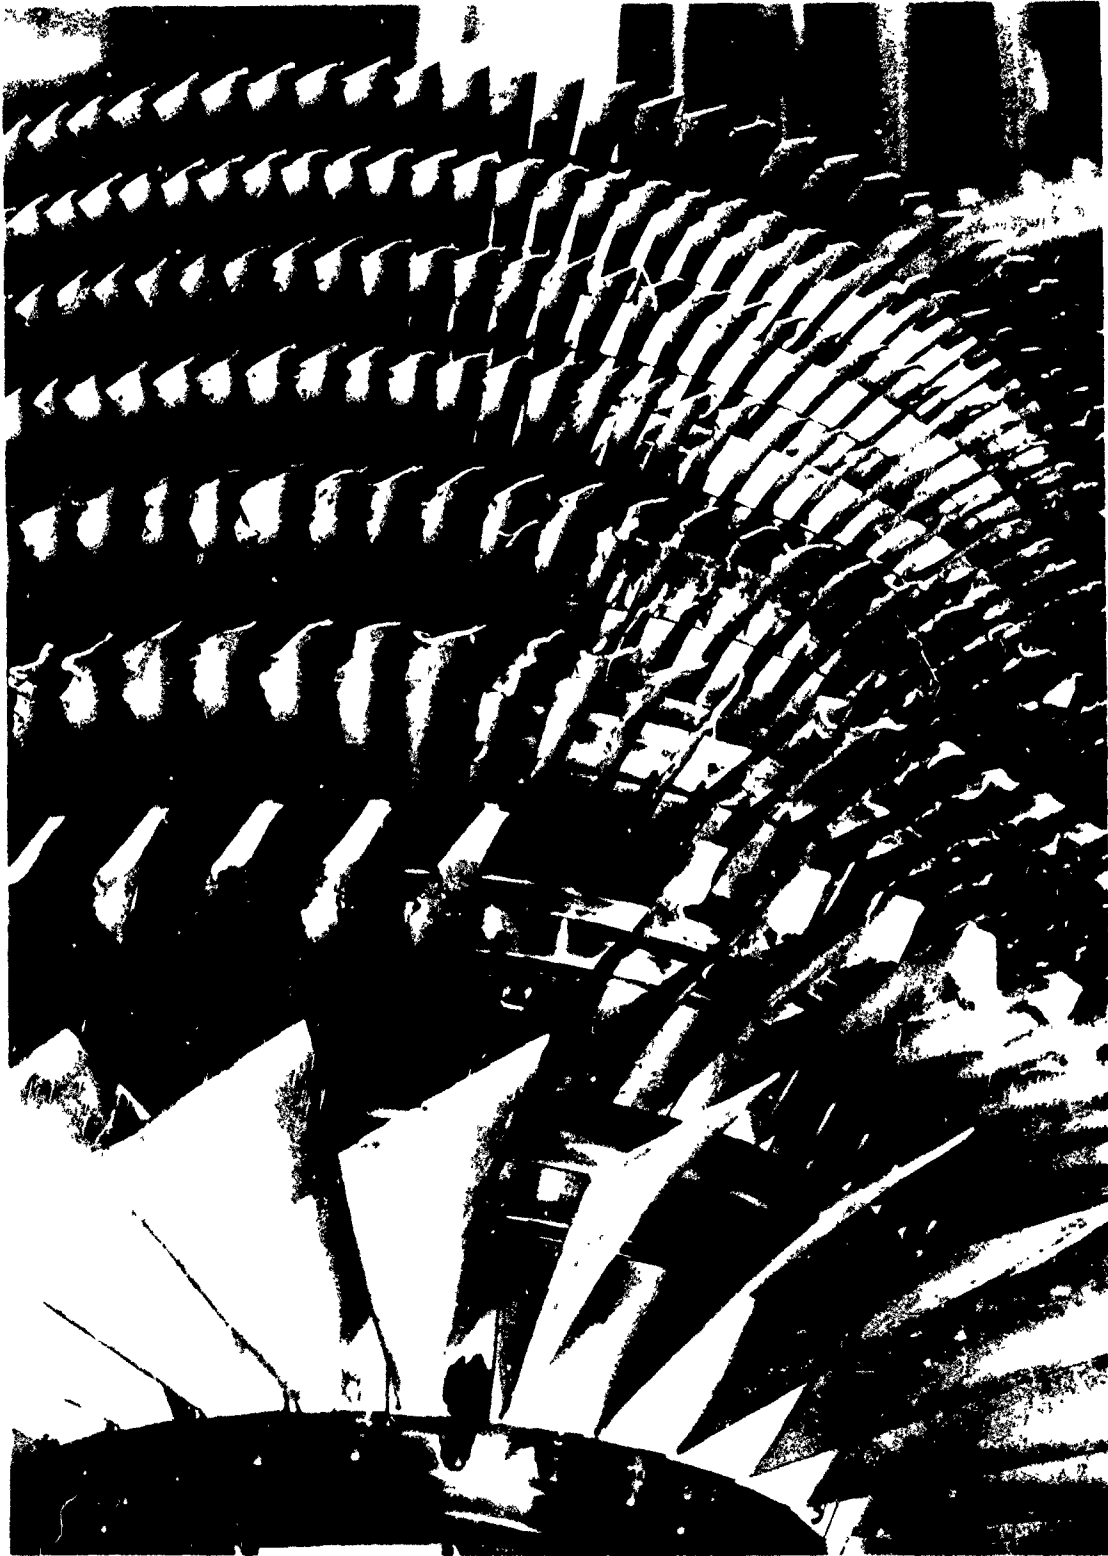
Figure 47 - Second Stage Blade Failure at 1007 RPM (185 Engine)

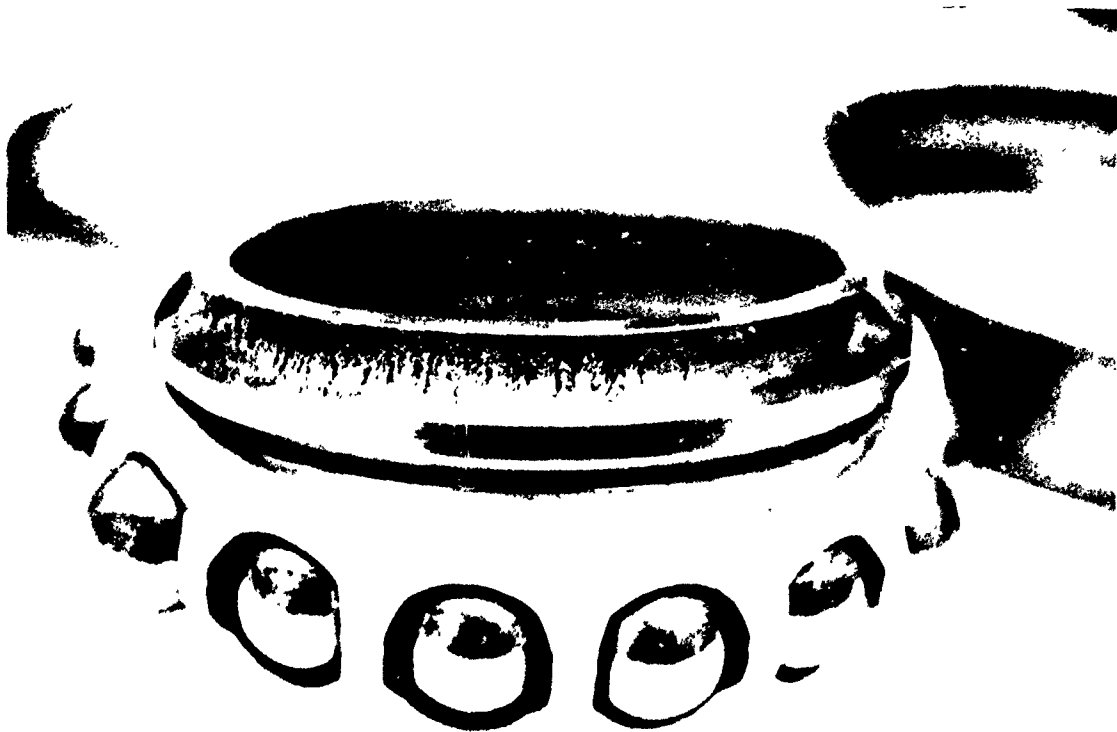
Figure 52 - Incipient No. 2 Bearing Fatigue Failure

No engine malfunction had been caused by this bearing. All that might be noticed when a bearing reaches this condition would be an increase in vibration level, and some steel particles in the lubrication filter.

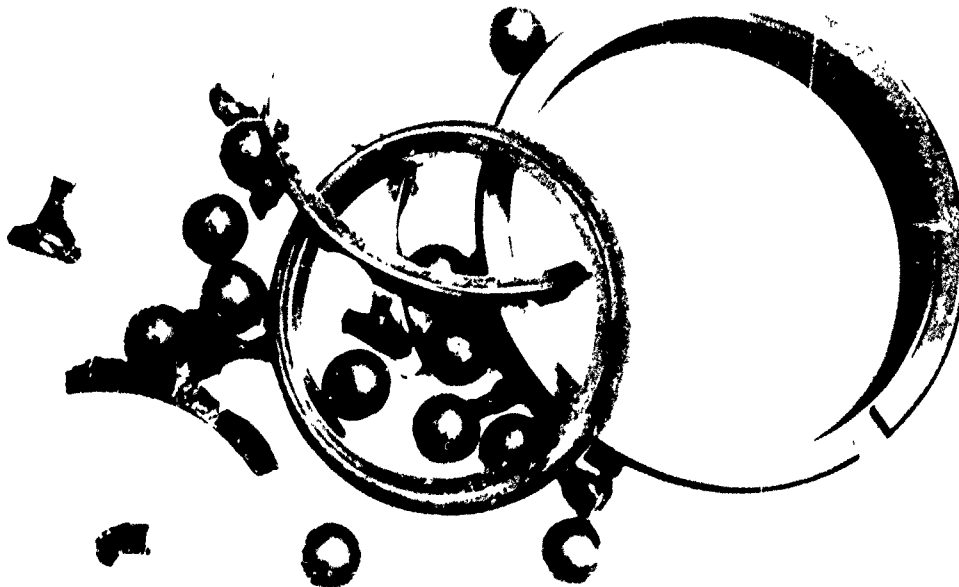
Figure 53 - No. 2 Bearing Fatigue Failure

This bearing caused an engine failure.

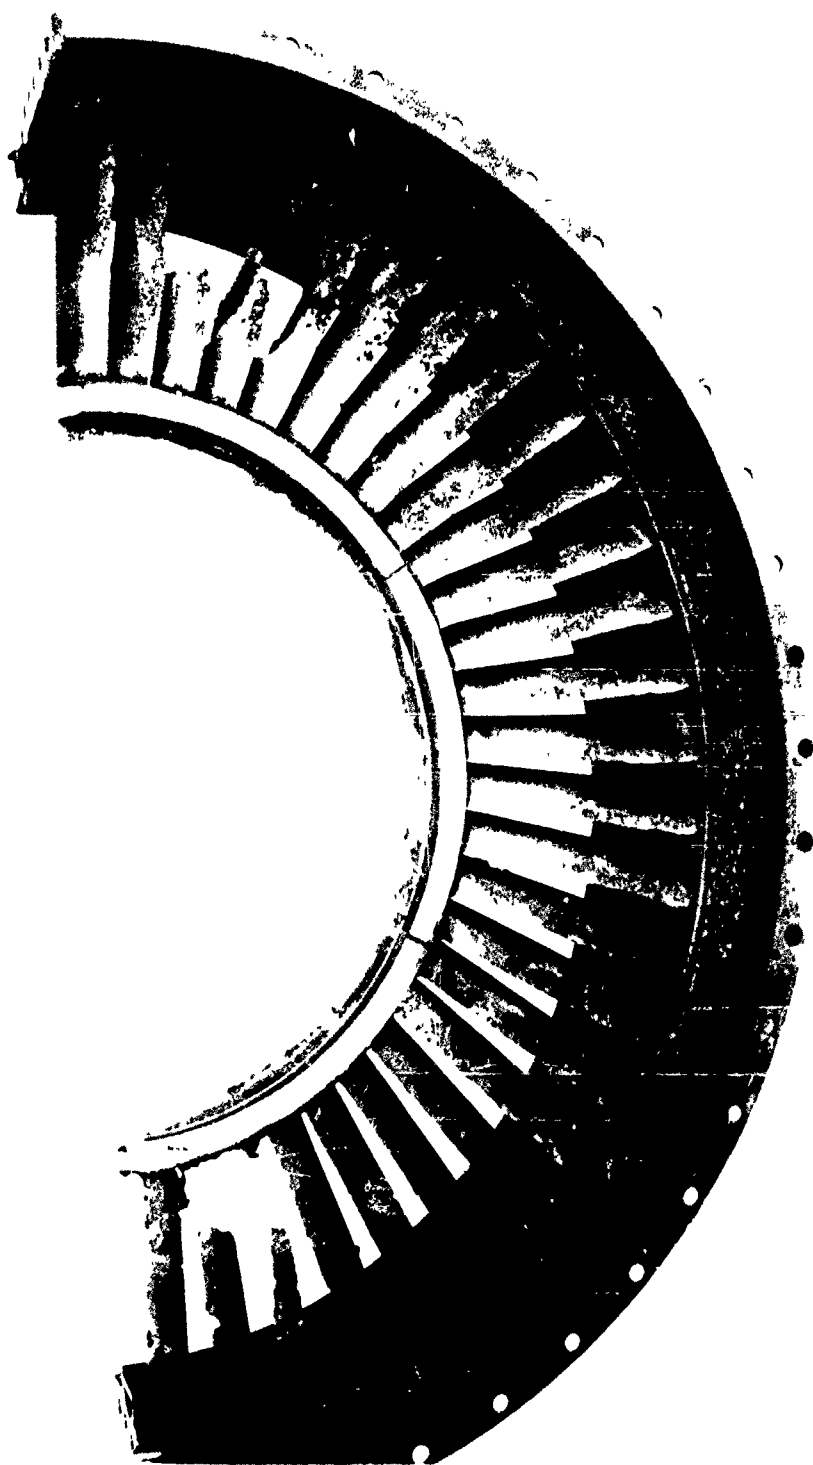
Figure 54 - Burned 2nd Stage Turbine Nozzle (I85 Engine)

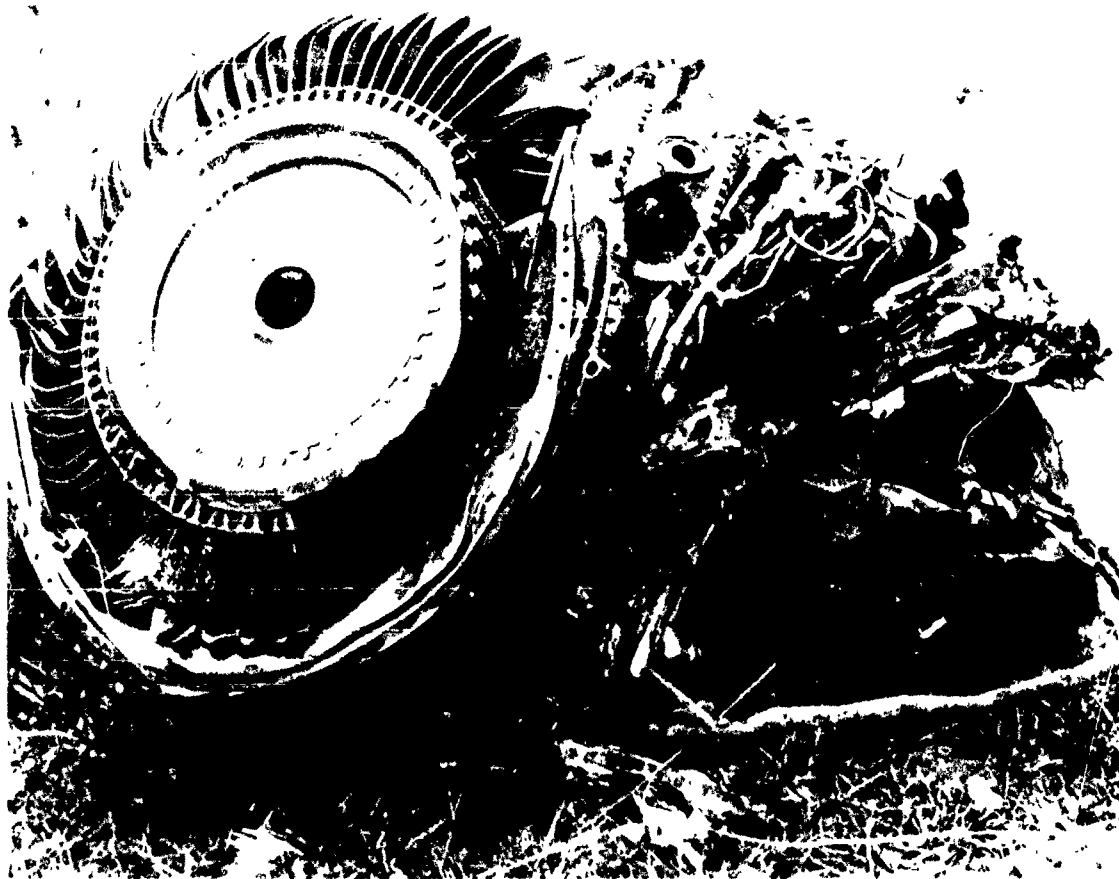
FIGURE 55 - TURBINE ROTOR THAT WAS OPERATING AT 83-85% RPM AT
TIME OF IMPACT. NOTE HIGH IMPACT DAMAGE.

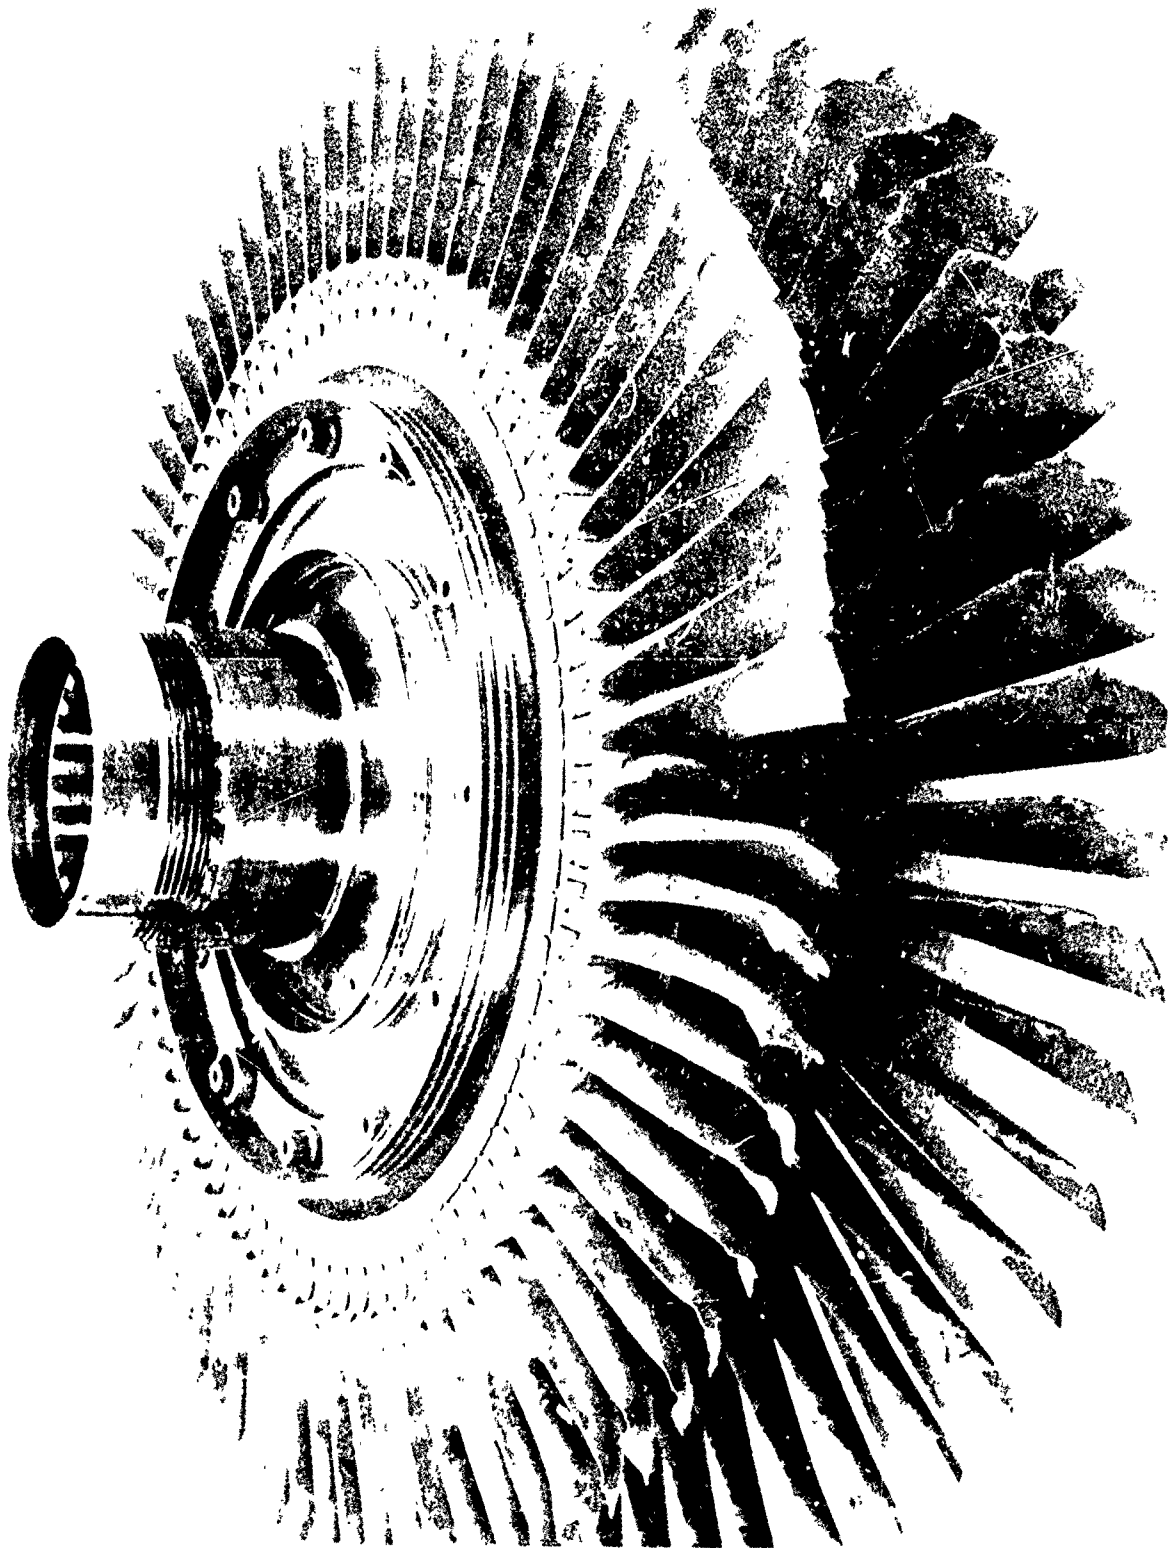
Figure 58 - Second Stage Turbine Blade That Failed From Stress Rupture At 100% RPM During Free Overtemperature Operation (185 Jet Engines)
